MERRIMACK RIVER BASIN  
MEREDITH, NEW HAMPSHIRE

LAKE WAUKEWAN DAM  
NH 00306

PHASE I INSPECTION REPORT  
NATIONAL DAM INSPECTION PROGRAM

OCTOBER 1978

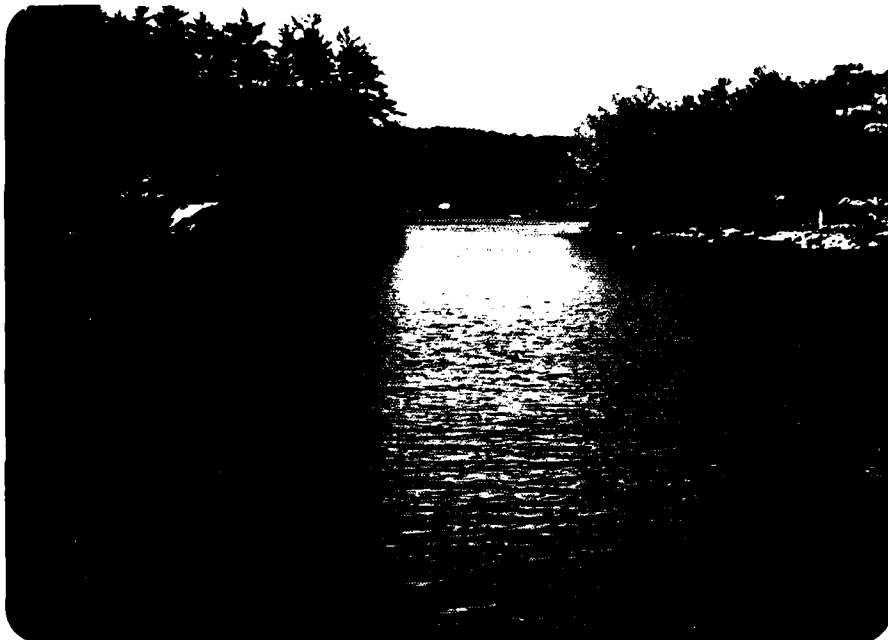
Photo 1 - View of Lake Waukewan from the head of the inlet canal.

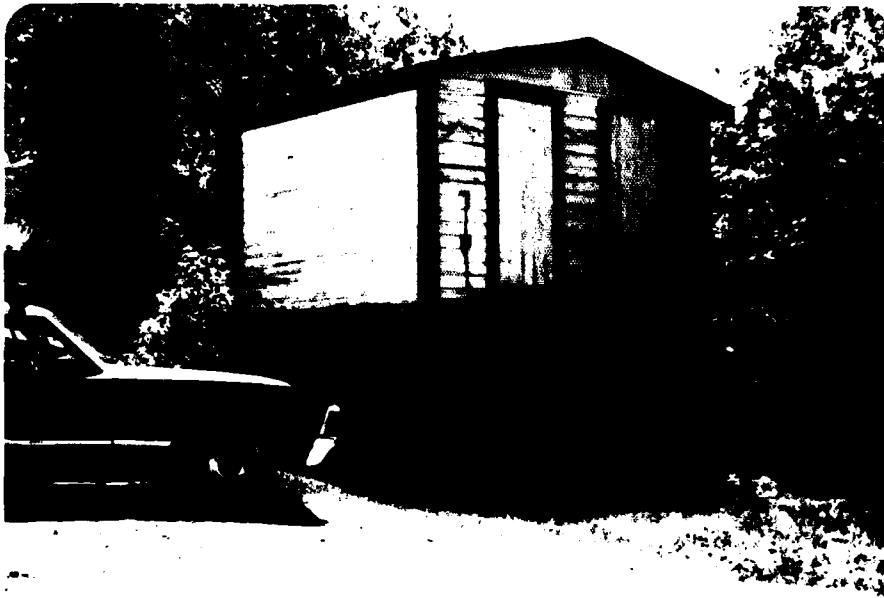
The gate house walls are of reinforced concrete construction. No leakage water or wet ground conditions were observed at the gate house structure. The gate house superstructure was of wood construction with siding and has a conventional roof covered with asphaltic sheet roofing material. The gate house was in acceptable condition.

Photo 3 - Gate house astride the 6-ft. diameter penstock. The gate inside is of timber construction, and can block off water for downstream maintenance.
